Intel® 82801CAM I/O Controller Hub 3 (ICH3-M)

Specification Update

March 2006

Document Number: 290718-010

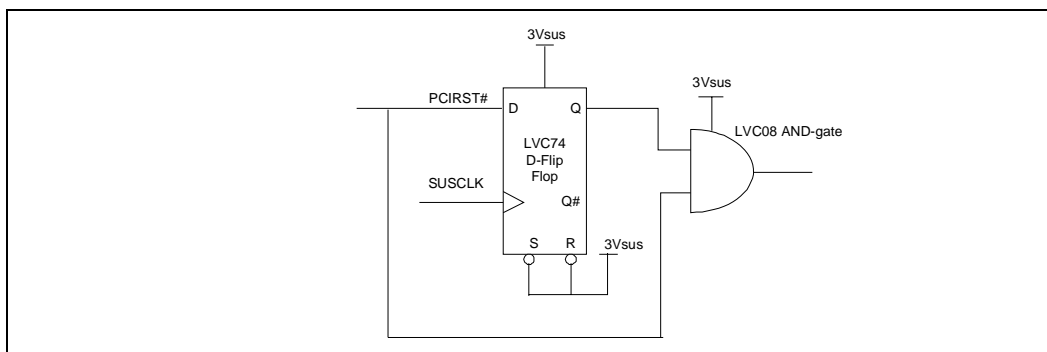
Implication: Some LPC devices may not properly reset resulting in failure of the system to boot or resume from a sleep state.

1. Delay PCIRST# by 1 SUSCLK using a D-flop and an AND gate to the LPC devices.
